Betsie River & King Road Improvement

October 2010

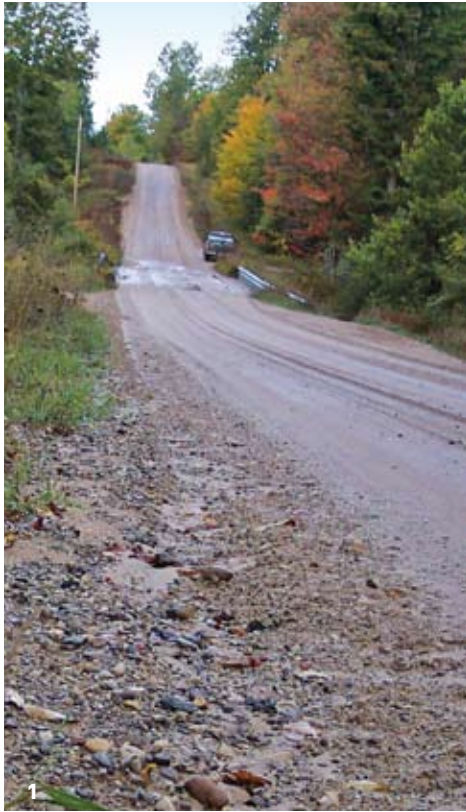
1. Before - sand and gravel repeatedly washed down the approaches. 2. During construction. 3. Spillways handle runoff and filter out sediment. 4. After - pavement is the only effective solution.

There are 106 road/stream crossings inventoried in the watershed with 64 of them recommended for repair or replacement, a costly endeavor. Site #B-20 is where King Road crosses the Betsie mainstem. This site was ranked severe for its steep, sandy road approaches that eroded during rain and snowmelt events, washing tons of sand over the bridge deck and into the river. Site #B-20 is located on the upper third of the river; thus with the Betsie being 52 miles long, the sediment from King Road impacted over 30 miles of the river downstream. By partnering together, funding was secured to enable the Benzie County Road Commission to pave and curb the approaches, and install spillways to channel runoff away from the stream, to nearby land.
