Dair Creek Recovery

June 2006 through October 2009

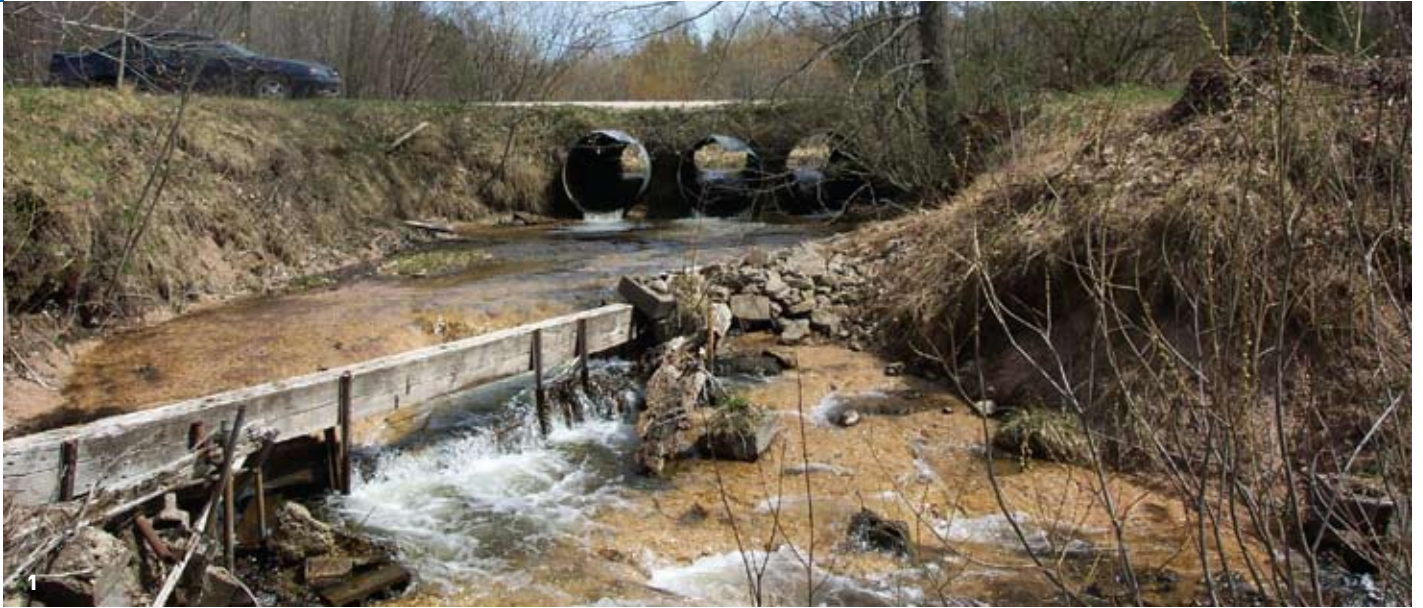
1. Before - aging culverts and dam remnants were an unsightly problem on Dair Creek. 2. After - a bottomless arch accommodates fish passage.

- Dam removal
- Re-route & restoration of 500' of stream channel
- Triple 5' diameter culverts replaced with a 13' wide bottomless arch, 4'1" high, 60' long
- Single 24" diameter culvert replaced with a 10' wide bottomless arch, 4'6" high, 54' long
- 150' of road embankment stabilization
- 400' of pavement and 2 spillways
- 100' of woody debris & fish habitat platform structures
- 80 cu.yds. fieldstone placement
- Removal of 30 cu.yds. sand
